Quarry Park

A review of the proposed South Ridge fire road plan.

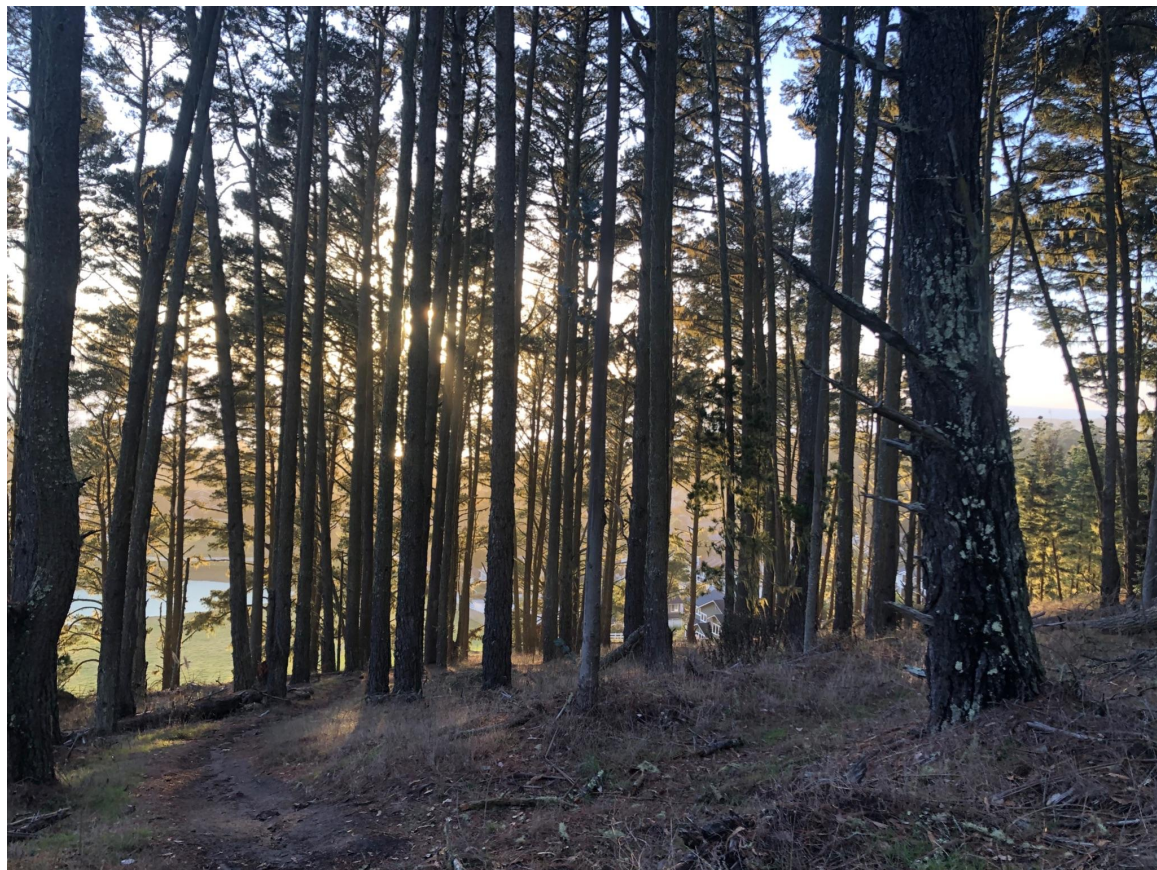
Start of proposed fire road on Coronado Ave.

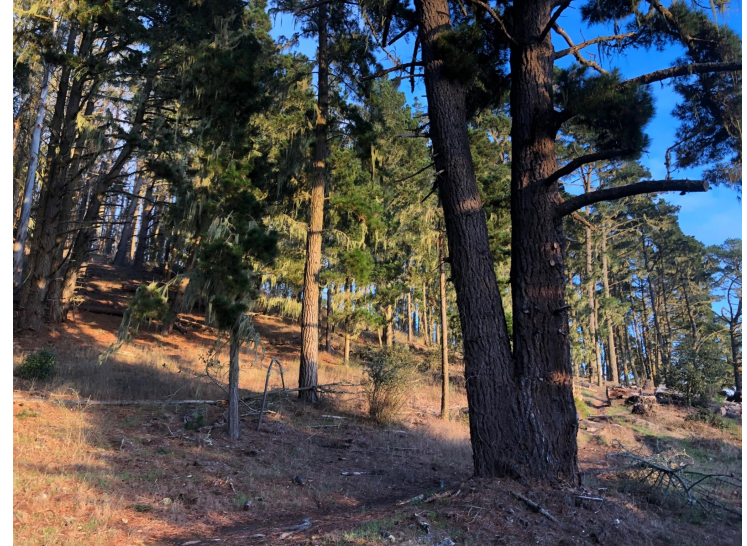
Examples of erosion caused by fire roads in Quarry park

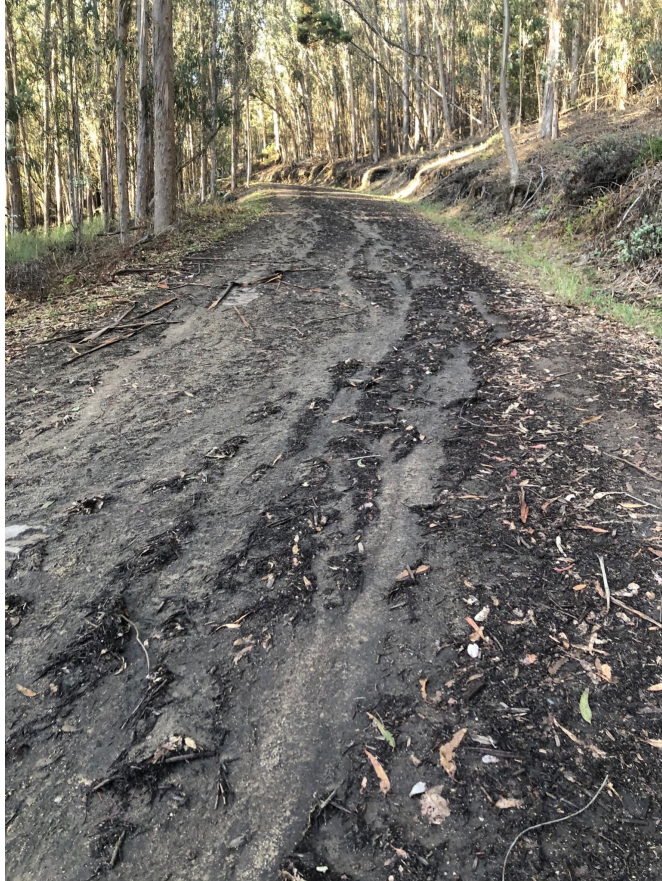
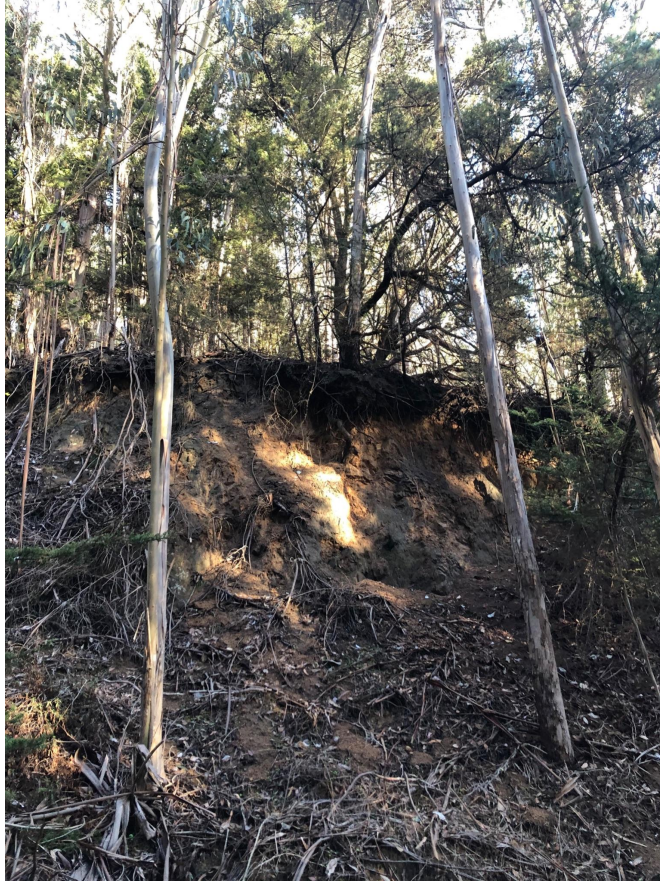
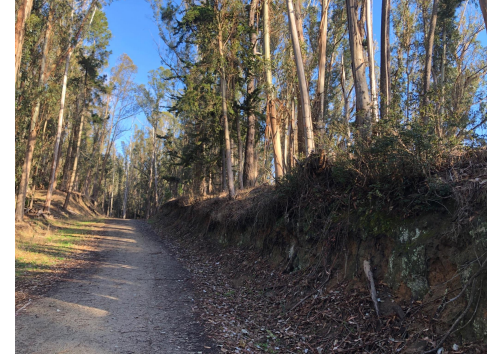
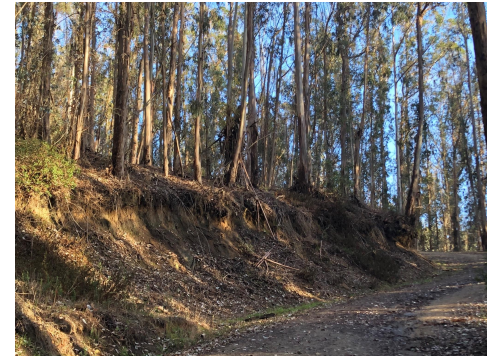
Examples of slides caused by fire roads.

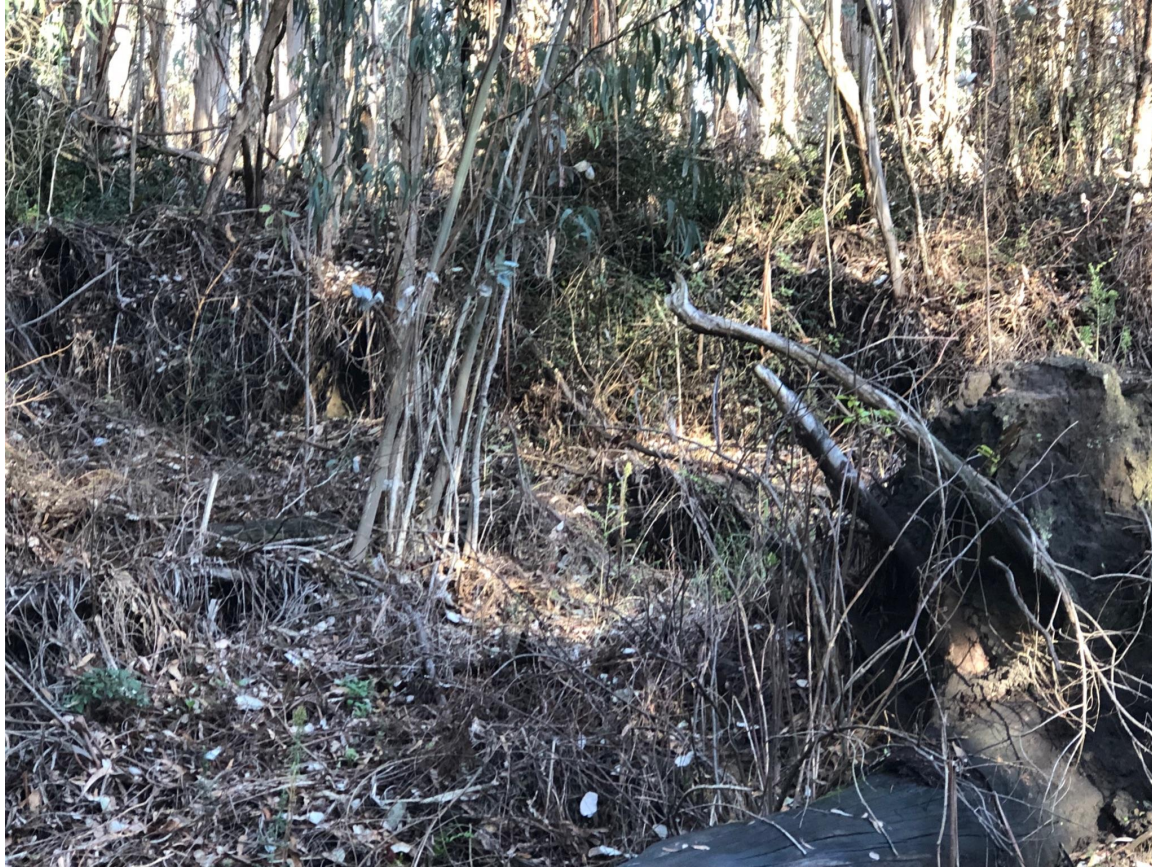
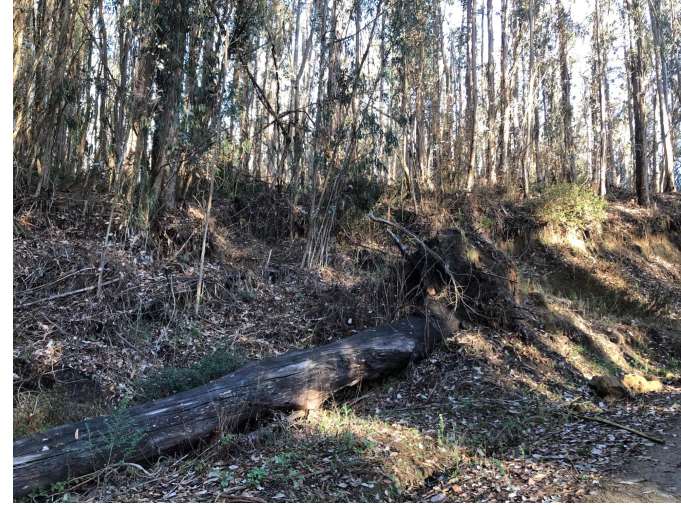
If you look closely to these two photos, you can see the sinkage and sliding of the forest floor.
