Quarry Park

A review of the proposed South Ridge fire road plan.

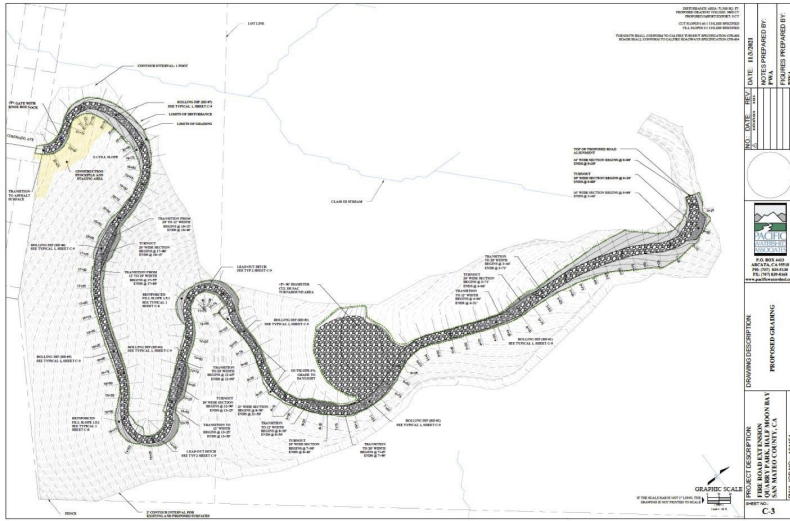
Figure 6 South Ridge Trail Fire Road Grading Plan
 Quarry County Park Wildfire Reduction and Visitor Serving Project

This is the proposed location of the South Ridge Fire Road. It begins at the east end of Coronado Ave in the Miramar community of Half Moon Bay.

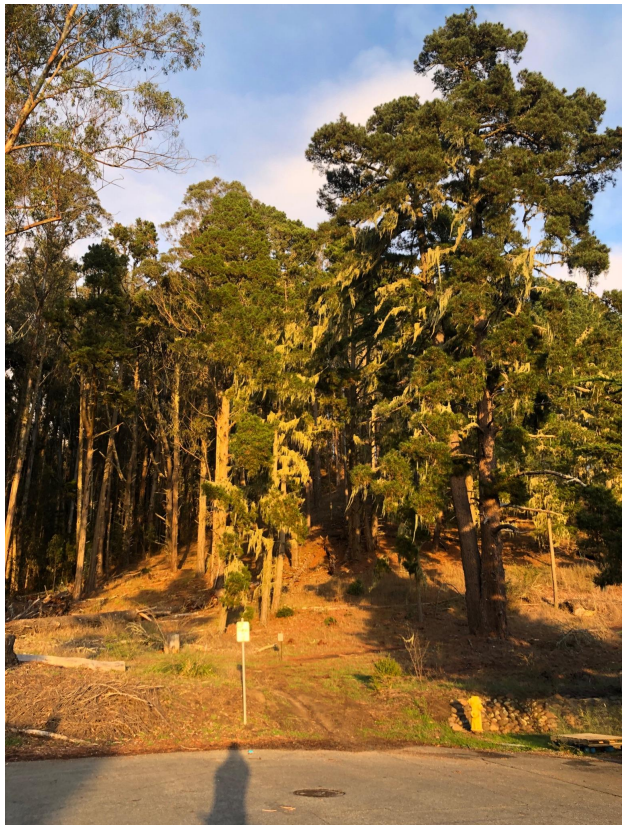
Start of proposed fire road on Coronado Ave.
