FIRST RAIN 2020 RESULTS

In partnership with the Monterey Bay National Marine Sanctuary, Surfrider Foundation, County of San Mateo Public Health System, Sewer Authority Mid-Coastside, and the San Mateo County Harbor District, the San Mateo Resource Conservation District (RCD) held the 2020 First Rain (First Flush) program in San Mateo County in 2020.

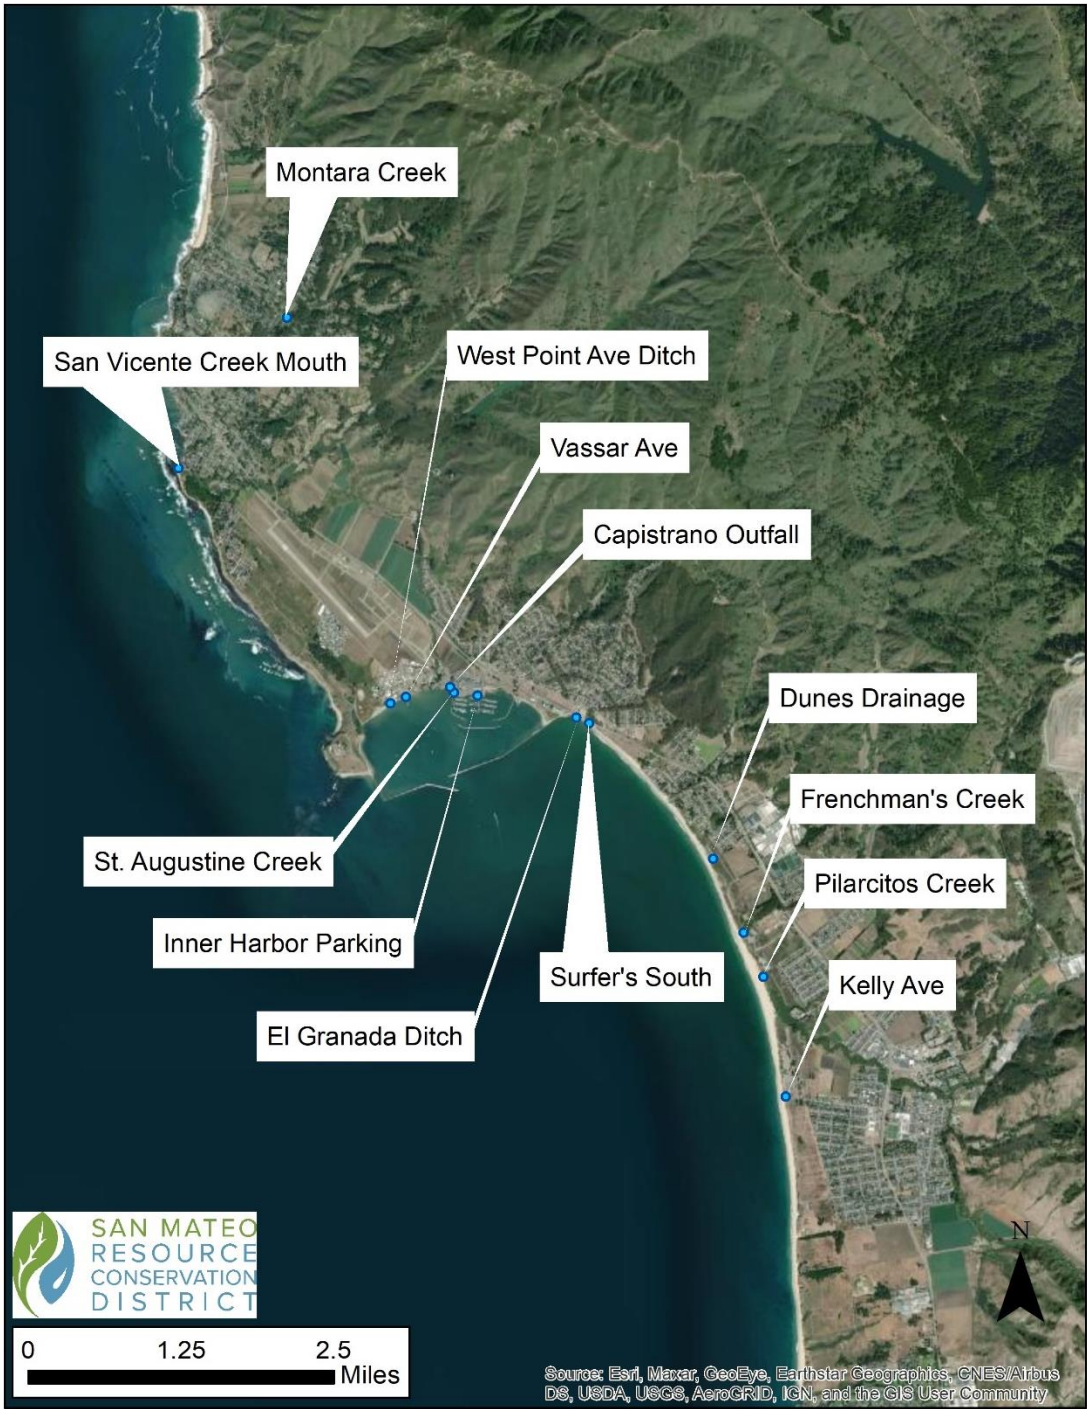
Figure 1. San Mateo County First Rain (First FLush) 2020 Site Map

On November 17, 2021, 20 volunteers sampled creeks and stormwater outfalls between Montara and Half Moon Bay on the Coastside of San Mateo County. Water samples were collected from 12 sites (see map below) and taken to the San Mateo Public Health Laboratory and to Monterey Bay Analytical Services and analyzed for Fecal Indicator Bacteria (FIB; *E. coli* & *Enterococcus*), Nutrients (nitrates and Orthophosphates), Metals (copper, lead, zinc), and Total Suspended Solids (Additional information on the pollutants tested for are provided in Table 1).
